CHIRP FEEDBACK

Issue No: 39

Spring 2009

A General Aviation Safety Newsletter

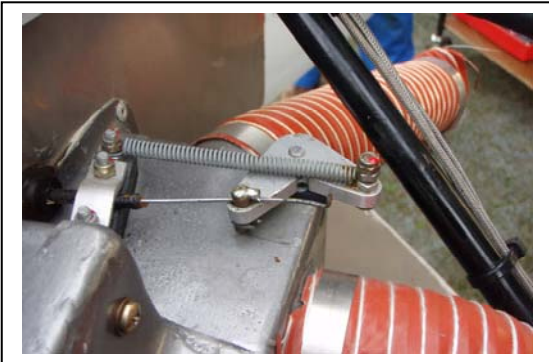
We had only just bought the aircraft and were very inexperienced in its operation but had planned to spend a "hands on" day with the LAA Inspector, during which we would go over everything to do with maintenance. This took place a few days later and during the course of it, we discovered that the soldered attachment of the Carb Heat control Bowden cable had become detached from the sector arm of the hot air intake (see photo). This sector arm has an "over centre spring" which can keep the intake either open or shut. In this case it was permanently open. No danger of icing but a significant drop in power.

We were very lucky. The combination of an unfamiliar aircraft, equipment failure and poor runway surface could easily have resulted in a disaster. In future, I will take more care in observing a significant (even if small) power drop on Carb Heat application. Carb Heat ON can be just as dangerous as Carb Heat OFF.

Remember, you should see a power drop on a pre-flight Carburettor Heat check. Do you know what power drop you should expect; also what would you do if the rpm after the pre-flight check is higher than before? If you don't know, find out; you could avoid a serious accident. [See CAA GA Safety Sense Leaflet 14 - Piston Engine Icing].
