Confidential Human Factors Incident Reporting Programme

FEEDBACK

AUGUST 1990

NUMBER 22

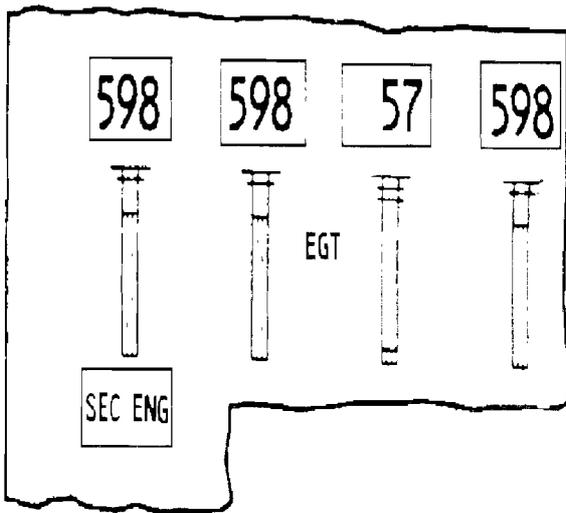
The picture on the left shows part of a “page” from a screen in a glass cockpit. The “SEC ENG” caption here could actually relate to any engine (you have to call up another page to find out which), but it's easy to see how a pilot could get the message from this display that the problem is with No.1.

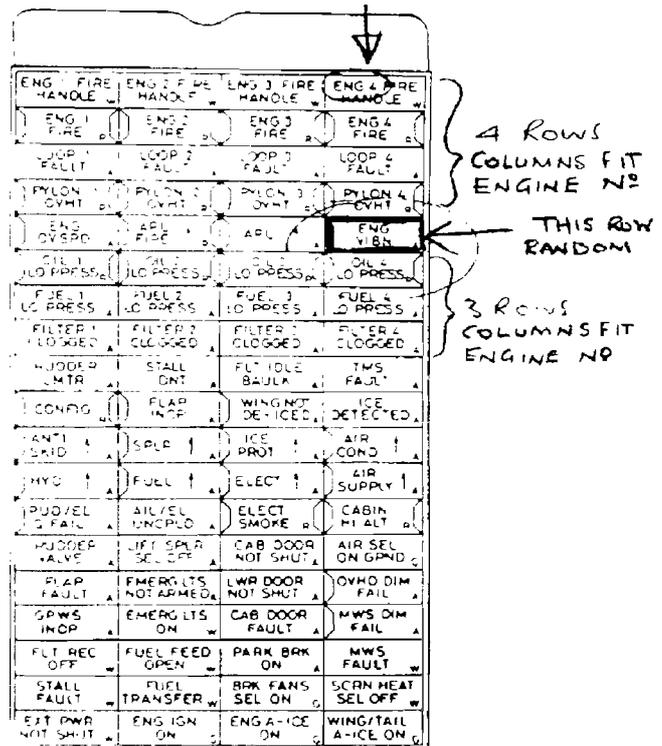
The picture on the right shows a similar problem. Rows 1-4 and 6-8 in this panel are all arranged in four columns associated with engines 1-4. Row 5, however, isn't like that! Easy to think when the ENG VIBN lights up (which could be from any engine) that it is a fault on No.4?

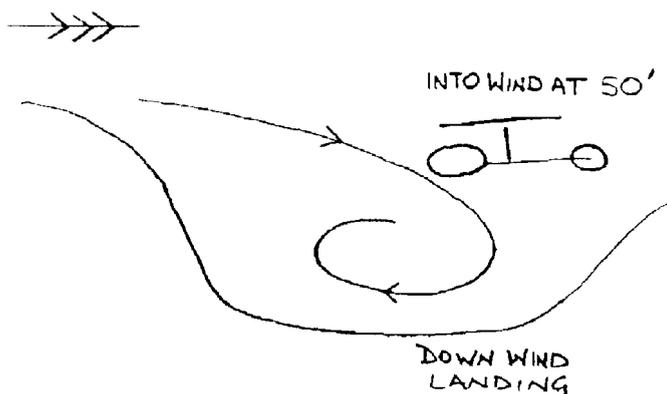
ATTACHED: Small sketch showing wind/landing pattern.

● Patrolling power lines after the recent storms. A very windy day with heavy showers, we flew through a particularly heavy shower (anti-ice on, pitot heat on, reduced speed etc. no problem) suddenly "whoosh-whoosh whistle" the blade tape had come off one main blade causing an increase in vibration and a pretty whistling noise. Still no big problem. Look for somewhere flat and level to land in order to strip off the offending tape. There in the valley bottom was a small paddock. I started a descent, turned into last known wind direction (230/40) when at about 50ft AGL and 20kts IAS the aircraft started to sink rapidly. Full power and some (110% TQ) just stopped the sink and we arrived a bit breathlessly. What went wrong? Silly me forgetting that wind directions change so quickly in hilly country - I was 180 degrees out of wind on landing although into wind at 50ft AGL. If I had been heavier or slower reacting then we would have bent it.

You still learn after years and years. Don't let one problem make you operate hurriedly and cause a bigger problem.

☞ Prompt recognition and action can 'save the day' if the error is noticed as soon as the results begin to show. Don't think it can't happen to you because there are 'design failures' present in any human being. In some ways, the more highly skilled you are the more you are open to error.
