CHIRP FEEDBACK

Issue No: 46

Winter 2010

A General Aviation Safety Newsletter

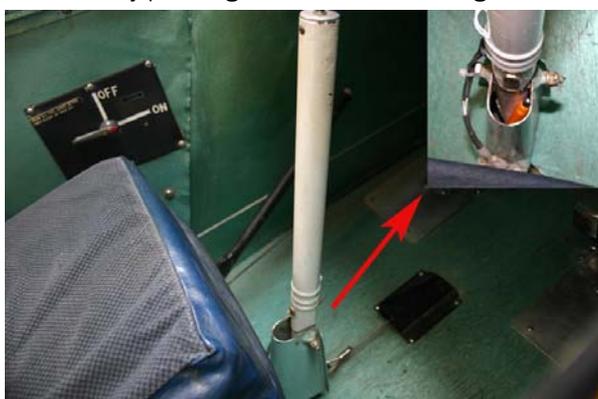
I had left my kneeboard and biro on the front seat ready to pick up as I got in. When I moved the elevator from the outside to check for full and free movement it jammed fully up. There was nothing visible in the cockpit to cause a jam and the elevator felt solid when trying to move the stick or the elevator itself.

I de-planed my passenger and removed the appropriate access panels to locate the problem. I found no evident foreign objects or damage. At this point I looked more closely at both control columns. They are linked by a fore and aft tube fixed at the base. The front control column is bolted to a curved fitting with a gap at the front of the stick. As you can see from the photo the gap is fairly small, but it was large enough to accept a plastic pen which then was nicely hidden behind the fitting and acting as a very effective control lock. It was fairly easy to work it out once I had seen it. I did so, and replaced the access panels. After a second pre-flight I then flew my passenger on an uneventful flight.

Lessons Learned: Despite this being the second flight of the day, I carried out a full pre-flight inspection; obviously a useful thing to do. What was not so clever was leaving loose articles on the seat while doing the external walk around. I am considering how to make a sock around the stick to avoid this happening again, and am tying my biro to my kneepad. Oh, and using only light, fragile, pens. This could have been a lot worse if the pen had fallen in during the flight.

CHIRP Comment: This is a useful reminder of the potentially hazardous implications of a loose article. If you lose a pen or other small item in the cockpit, make a thorough search before flying again.

One option with a control configuration similar to that in the photograph above is to fit a flexible 'glove' around the base of the control column, similar to that on the gear lever of many cars.
