CHIRP GA FEEDBACK

Issue No: 62

4/2014

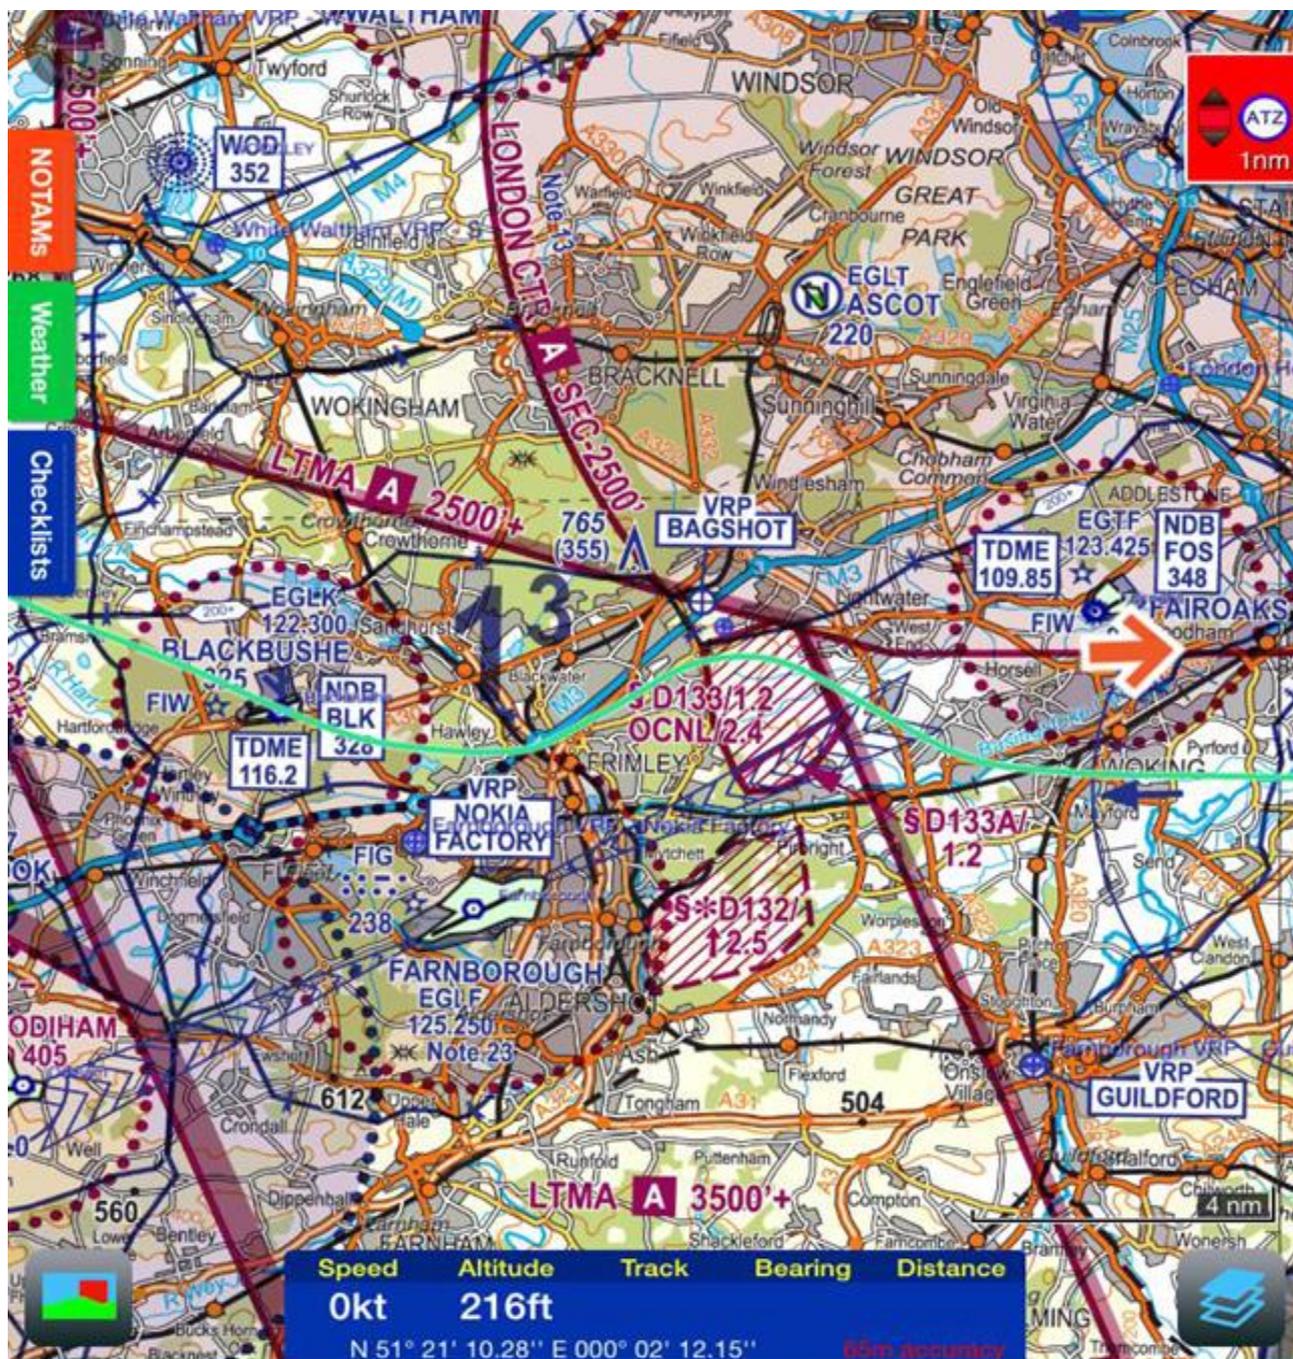
Report Text: I was flying on a VFR flight in VMC. I was receiving a Basic Service, squawking Mode C and flying at 2,400 feet QNH. My co-pilot was operating the radio and I was handling the aircraft. The controller requested my assistance and asked me to turn left to avoid jet traffic that was established on the ILS to runway 24 at Farnborough. I changed heading to follow the M3 as requested. This new track took me towards the Bagshot radio mast on the Western corner of the Heathrow zone. As I approached the Bagshot radio mast I turned right onto an easterly heading to avoid entering the Heathrow zone. [See print from flight log below with the route shown in green].

My co-pilot questioned this decision as I had been instructed to follow the M3. After a short time, the controller thanked me for my assistance and said to resume own navigation towards the Ockham VOR. After landing we checked our plot on the iPad mapping software, which confirmed that we just remained clear of the Heathrow zone. A discussion ensued with my co-pilot and other pilot as to whether we should have carried out the instructions of the controller or taken the decision to change heading to avoid entering Heathrow Zone. There were a number of opinions as to what the correct action was.

instance we had two choices, continue as instructed into Heathrow's Zone or turn right and possibly cause a conflict with IFR traffic on an ILS. There was insufficient time to contact the controller and make him aware of our dilemma. I took the decision not to enter Heathrow Zone, which in the end didn't cause a problem but it could have been very different. My suggestion would be to make other pilots aware through publishing articles of this possible conflict to avoid difficult decisions having to be made in the air.

CHIRP Comment: The reporter showed commendable awareness and common sense. It is unusual to be left in circumstances where there is a decision to make; normally one would expect to resume own navigation as soon as the traffic on the approach was clear. A common ATC technique is to provide Traffic Information and allow pilots to resume their own navigation with the traffic in sight. However, the bottom line is that pilots should not enter controlled airspace unless they have been specifically cleared to do so. The reporter acted correctly.
