# CHIRP GA FEEDBACK

Issue No: 73

3/2017

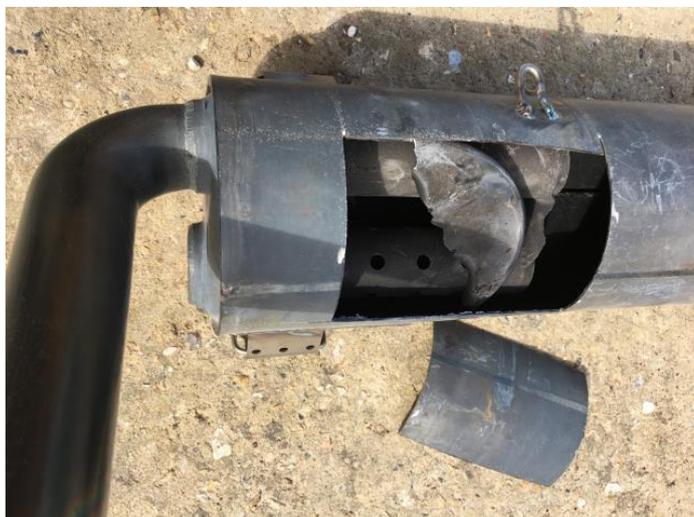
Following shutdown and investigation it was found, after removal, that the titanium exhaust silencer 'rattled' when shaken and obviously had some loose object inside. The body of the silencer had 'ballooned' and expanded.

The silencer was returned to the manufacturer who cut it open for inspection. Part of the internal baffle was found to have detached and it is assumed that this had effectively blocked the exhaust pipe at some point in the descent, over pressuring the silencer and causing the engine failure. It is also possible that the over pressure had caused hot gases to leak past the spring loaded individual

cylinder head exhaust attachments and thus caused the hot air entering the cockpit as the throttle was advanced on the approach.

The exhaust silencer has now been replaced by a stainless steel version which hopefully will not be as susceptible to engine vibration as the more brittle titanium one.
