GA FEEDBACK

No: 9

September 2001

A General Aviation Safety Newsletter

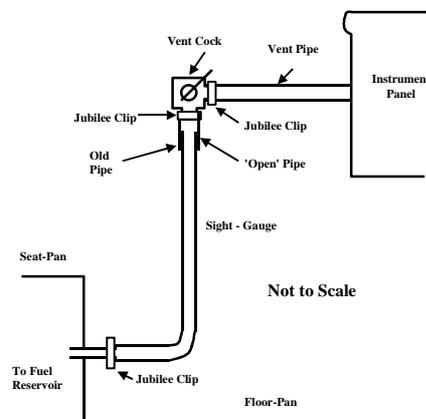
When the side panel was removed to investigate the fuel leakage, it was discovered that the sight-gauge tubing had been replaced with smaller bore pipe-work than the original. Because this smaller pipe could not be expanded to fit over the air-vent cock connection, it had simply been stuffed into the short length of old tube still remaining.

In effect the fuel tanks were connected to the cockpit by an open pipe! The main fuel cock does not isolate the sight-gauge.

Don't wait - investigate!!

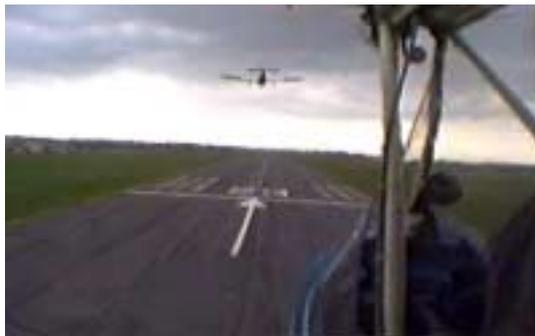
I enclose a copy of the video. The camera is fitted with a wide-angle lens, so the separation between the two aircraft looks greater than it was in reality.

This was a classic example of each aircraft being positioned on the final approach in the other's blind spot as a result of the High wing configuration microlight and the Low wing overtaking aircraft.

To avoid this type of situation, in the absence of a published arrival procedure, a standard overhead join should be flown, particularly if no radio contact has been established. CAA Safety Sense leaflet 6B - 'Aerodrome Sense' refers.
