CHIRP FEEDBACK

Issue No: 98

2/2011

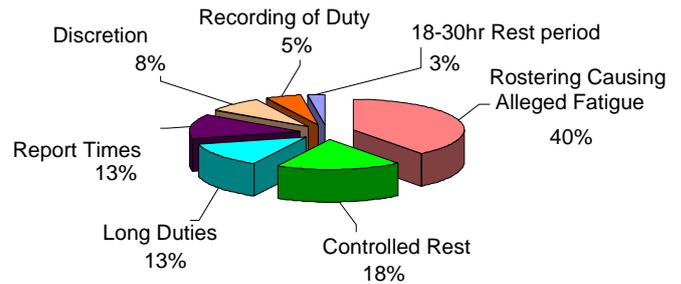
Flight Crew Duty Report Issues - 2009

The largest category of reports, allegedly poor rostering practices (13 reports; 37%), was similar to previous years although the specific issues raised by reporters within this category were different and in several cases company specific, as detailed below. One of the more significant issues reported in previous years, the routine scheduling of rest periods between 18 and 30 hours, predominantly by one UK operator (Operator L), appeared to have been resolved.

The second most frequently reported topic involved rest (8 reports; 23%) and principally the practice of 'Controlled Rest', which had also been the subject of a number of cabin crew reports by cabin crew members employed on long haul operations by one UK operator.

Within the remaining categories, the publication of Flight Operations Department Communication (FODCOM) 10/2009 in April 2009 clarifying several rostering practices appeared to have been effective in addressing some of the innovative interpretations by some operators, such as the adaptation of standard FTL variations for use by more than one crew and extending the maximum Flight Duty Period by the use of additional flight crew members positioning in the main passenger cabin. No reports on these topics were received during the 2009 summer season. One issue referenced in FODCOM 10/2009, the adequacy of report times, continued to be reported; five reports expressed concerns about changes associated with pre-flight duties that were not acknowledged in the report times, either due to the report location being moved airside or changes in the method of obtaining the relevant operational information (hard copy replaced by downloading electronic data); four reports in this category were received in the final quarter of the period.

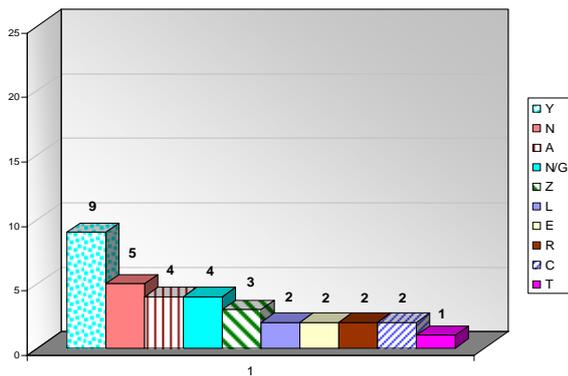
Duty Report Issues by Operator - 2009

Nine reports (38%) of the total received referenced Company Y and involved two separate concerns. The first was the introduction of an additional schedule to the Far East and Australia in which the stopover periods had been reduced. The reports alleged a significant increase in tiredness levels on the return sectors, particularly the inbound sector to the UK. The schedule was assessed using the SAFE 'Work-Rest' computer programme developed by QinetiQ for the CAA; this showed that whereas the predicted level of tiredness was lower for the second outbound sector due to the re-timing of the schedule; that for the final sector was higher than the original schedule. Similar representations were also made to the Company regarding the levels of tiredness. The matter was brought to the CAA's attention; however, shortly thereafter, the Company elected to discontinue the additional schedule. The second issue was associated with the use of the two crew Florida 2 (F2) Variation to/from US destinations; the reports alleged that an increase in the frequency of use of the variation leads to crew members being rostered for the maximum number of F2 schedules permitted, causing fatigue.

The predominant issues in reports related to Company N were the poor planning and management of some rosters/duties; several quoted unrealistic sector/turnaround times associated with FDPs at or close to the maximum permitted. As noted above, all of the reports related to Company A were comments in response to cabin crew concerns about the frequency of use of Controlled Rest, as were the majority of unidentified reports. Among the reports submitted by pilots employed by other UK operators there were two points of note; the first was the difficulty experienced by flight crew members in completing required pre-flight duties within the time afforded by the scheduled report time (Company E, T, Y); the second was no/insufficient duty allowance for ground training tasks (Company R).

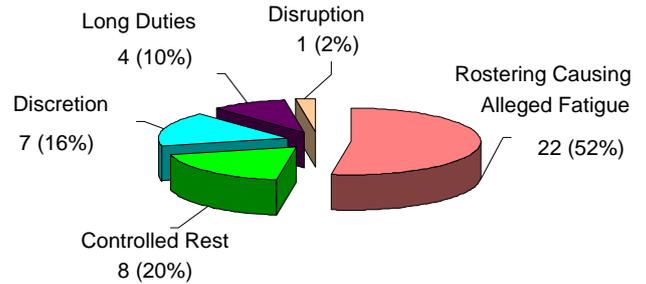
Flight Crew Duty Report Issues - 2010

Of the 42 reports received, 22 reports (52%) related to crew rosters or rostering of flight crew. As in 2009, this was the most frequently reported topic. Of the total in this group, 11 reports (50%) involved one operator. Specific issues included allegedly questionable roster practices, alleged company pressure on individuals to accede to roster changes for delayed flights/duty changes due to a lack of availability of standby crews, scheduling of flights that were technically just within the maximum permitted Flight Duty Period but with allegedly unrealistic sector times and/or turnaround times.

The second most frequently reported topic was rest (8 reports), also the same as in 2009. Within this group five reports raised continuing concerns about the use of bunk rest/controlled rest and involved more than one company. A related issue was the alleged deleterious effect of reducing an augmented three-crew operation on a long haul route under a Florida 2 variation to a two-crew operation.

Three reports related to the length of a scheduled flight duty. All alleged that the scheduled flight duty period could not be achieved in practice.

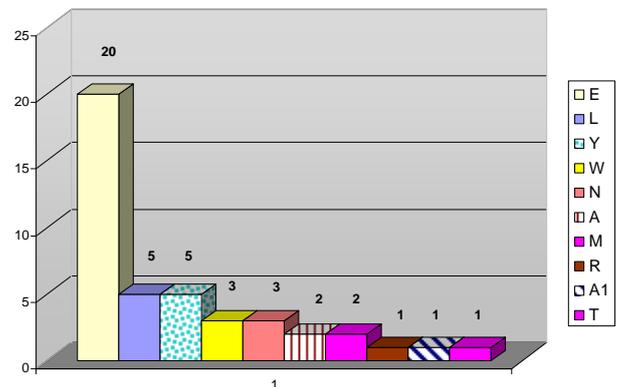
Duty Report Issues by Operator - 2010

Within the total of 45 FTL related issues raised during 2010, 20 issues involved one operator (Operator E), which interestingly, was operating a fatigue management programme during this period. The principal issue (11 reports) was similar to that for Company N in 2009, namely allegedly poor planning and management of schedules/rosters/duties; reported

problems included poorly planned schedules leading to delays, planned FDPs at or close to the maximum with unrealistic sector/turnaround times scheduled and a shortage of standby crew members. These problems contributed to the second issue, Discretion (6 reports), all of which alleged either pressure by management to exercise discretion or an assumption that a captain would exercise discretion. The remaining issues were associated with long duties by standby crews and inappropriate rest periods between long duty periods.

In the case of Company L, three reports involved the effect of roster changes at short notice involving switches from early to late duties or vice versa. Two raised concerns as to the adequacy of the pre-duty rest period after having being stood down from a standby duty to operate a later flight.
