CHIRP FEEDBACK

Issue No: 30

Winter 2006

Most frequent GA Issues Reported
12 months to October 2006

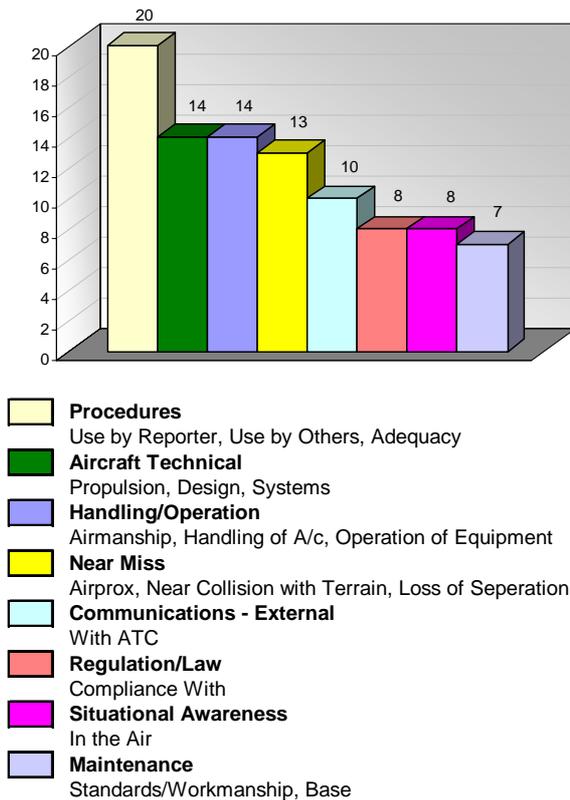
- Procedures**
Use by Reporter, Use by Others, Adequacy
- Aircraft Technical**
Propulsion, Design, Systems
- Handling/Operation**
Airmanship, Handling of A/c, Operation of Equipment
- Near Miss**
Airprox, Near Collision with Terrain, Loss of Separation
- Communications - External**
With ATC
- Regulation/Law**
Compliance With
- Situational Awareness**
In the Air
- Maintenance**
Standards/Workmanship, Base
