CHIRP FEEDBACK

Issue No: 32

Summer 2007

from **CHIRP** the Confidential Human Factors Incident Reporting Programme

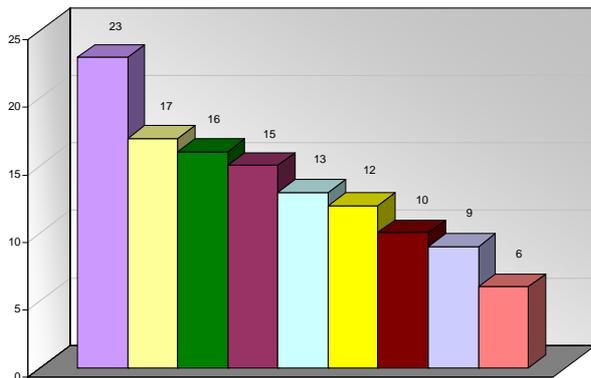
Most frequent GA Issues Reported 12 months to April 2007

Handling/Operation Airmanship, Handling of A/c, Operation of Equipment
	Procedures Use by Reporter, Use by Others, Adequacy
	Aircraft Technical Propulsion, Design, Systems
	Situational Awareness In the Air
	Communications - External With ATC
	Near Miss Airprox, Near Collision with Terrain, Loss of Separation
	Air Traffic Management Level of Service, Separation
	Maintenance Standards/Workmanship, Base
	Regulation/Law Non-compliance, Adequacy
