CHIRP FEEDBACK

Issue No: 35

Spring 2008

A General Aviation Safety Newsletter

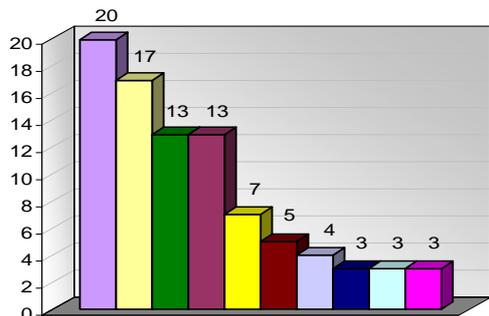
**Most frequent GA Issues Reported
12 months to February 2008**

- Handling/Operation**
Airmanship, Handling of A/c, Operation of Equipment
- Procedures**
Use by Reporter, Use by Others, Adequacy
- Aircraft Technical**
Propulsion, Design, Systems
- Situational Awareness**
In the Air
- Near Miss**
Airprox, Near Collision with Terrain, Loss of Separation
- Air Traffic Management**
Level of Service, Separation
- Maintenance**
Standards/Workmanship, Base
- Licensing**
Flight Crew, Engineering
- Individual Error**
Conflict, Lack of Leadership, Insufficient Team Work
- Ground Handling**
Loading, Refuelling, Taxiing

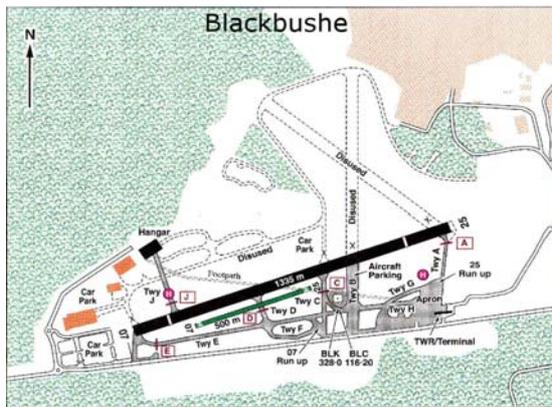
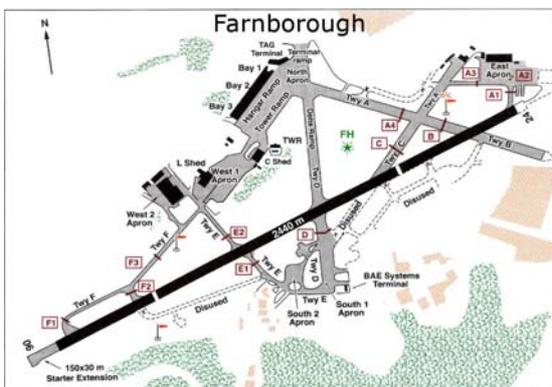
CHIRP Comment: The reporter is not the first to make this error. As can be seen from the two airfield diagrams, reproduced by courtesy of Pooley's Flight Equipment, the two airfields do have some similarities but also some significant differences.

Errors such as this often result from a well-known Human Factors condition known as 'confirmation bias' in which all of the information confirming the pilot's initial perception that the airfield ahead was Blackbushe was accepted, whilst other information available, such as the lead-in features, the large corporate jet facility on the Northwest corner of Farnborough, the prominent new control tower and the additional disused runways, was mentally rejected.
