CHIRP FEEDBACK

Issue No: 39

Spring 2009

A General Aviation Safety Newsletter

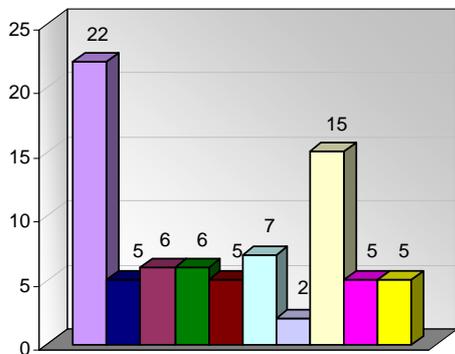
Most frequent GA Issues in CHIRP Reports 12 months to 30 January 2009

We have reviewed our method of analysing GA reports with the aim of providing better information on the reports that we receive. Reports received over the last year have been re-analysed in more detail. The chart shows the ten most frequently reported issues and a more detailed breakdown has been added to the chart legend.

- Handling/Operation**
Lack of Airmanship - 10, Aircraft Handling - 9, Operation of Equipment - 3.
- Communications - External**
Between Pilots and ATC - 5.
- Loss of Situational Awareness**
In the Air - 6.
- Aircraft Technical**
Systems - 3, Propulsion - 1, Design - 1, Performance - 1.
- Air Traffic Management**
Level of Service - 2, Procedures/Separation of traffic - 3.
- Individual Error**
Inadequate Skills/Knowledge - 3, Aircraft Handling - 3, Unsafe action.
- Airports**
Runway Incursion - 1, Taxiway Obstruction -1.
- Procedures**
Use by Reporter - 5, Use by Others - 7, Inadequate - 3.
- Regulation/Law**
Non-compliance - 4.
- Near Miss**
Air - 2; Ground - 2

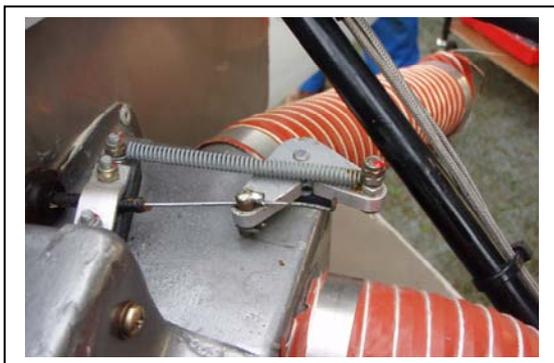
We had only just bought the aircraft and were very inexperienced in its operation but had planned to spend a "hands on" day with the LAA Inspector, during which we would go over everything to do with maintenance. This took place a few days later and during the course of it, we discovered that the soldered attachment of the Carb Heat control Bowden cable had become detached from the sector arm of the hot air intake (see photo). This sector arm has an "over centre spring" which can keep the intake either open or shut. In this case it was permanently open. No danger of icing but a significant drop in power.
