CHIRP FEEDBACK

Issue No: 41

Autumn 2009

Most frequent GA Issues in CHIRP Reports 12 months to 30 June 2009

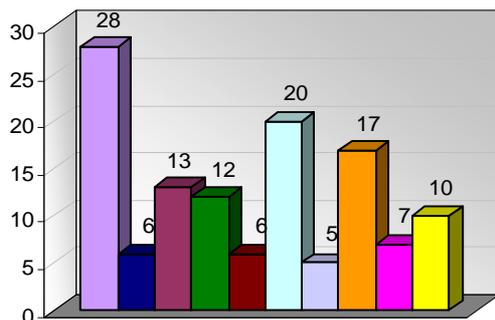
The chart shows the ten issues most frequently reported:

Handling/Operation (Lack of Airmanship - 9, Aircraft Handling - 17, Operation of Equipment - 2.)
	Communications - External (Between Pilots and ATC - 6.)
	Situational Awareness (In the Air - 13.)
	Aircraft Technical (Systems - 4, Propulsion - 2, Design - 3, Cabin 2, Performance - 1.)
	Air Traffic Management (Level of Service - 3, Procedures/Separation of Traffic - 3.)
	Individual Error (Inadequate Skills/Knowledge - 8, Aircraft Handling - 1, Lack of Confidence/Experience - 7, Reckless Behaviour - 1, Complacency - 3.)
	Maintenance (Installation Error - 1, Repairing Embodiment - 2, Servicing Error - 2.)
	Procedures (Use by Reporter - 5, Use by Others - 6, Inadequate - 2, Incorrect/Conflicting - 2, Knowledge Of - 2.)
	Regulation/Law (Non - Compliance - 6, Knowledge Of - 1.)
	Near Miss (Air - 7, Ground - 3.)
