CHIRP FEEDBACK

Issue No: 44

Summer 2010

Most Frequent GA Issues Raised 12 Months Ending 31 March 2010

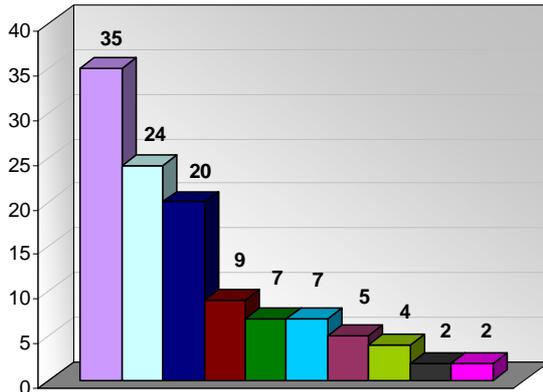
The Chart Shows the Ten Issues Most Frequently Reported:

- Handling/Operation**
Airmanship, Handling of A/C, Operation of Equipment
- Individual Error**
Lack of Experience, Overload, Inadequate Knowledge/Skills
- Communications - External**
With ATC
- Air Traffic Management**
Level of Service, Separation
- Aircraft Technical**
Propulsion, Design, Systems, Cockpit Equipment
- Near Miss**
Airprox
- Situational Awareness**
In the Air
- Maintenance**
Servicing Error, Standards of Workmanship
- Others/Undefined**
Personal/Domestic
- Regulation/Law**
Compliance Of, Knowledge Of
